Manhole Inspection Summary

Manhole # S2100_006MH

Insp Date: **10/9/08 9:04 AM**

Location Address: **N. FULTON AV**

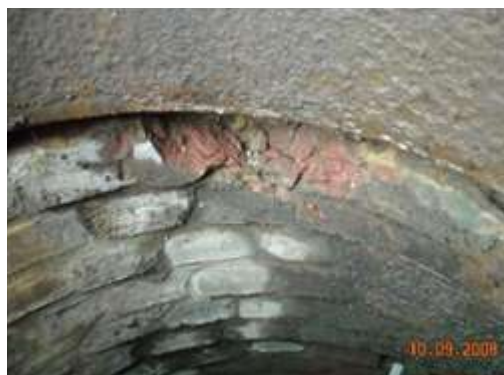
Defect

Frame Offset: **0** (in.) Condition: ☐ Sound ☐ Cracked ☒ **Leaks**

Condition: ☐ Sound ☐ Cracked ☐ Root Intrusion ☐ Loose Brick ☒ **Deteriorated**

Infiltration: ☐ None ☒ **Joint** ☐ Cracks ☐ Mortar ☐ Roots ☐ Wall

Frame leaks. Adjustment deterioration and infiltration.
